## Appendix C7

### ESEM/EDS Data for Test #5, Day-30 Birdcage Fiberglass

## Appendix D

### SEM/EDS Data for Test #5 Day-30 Deposition Products

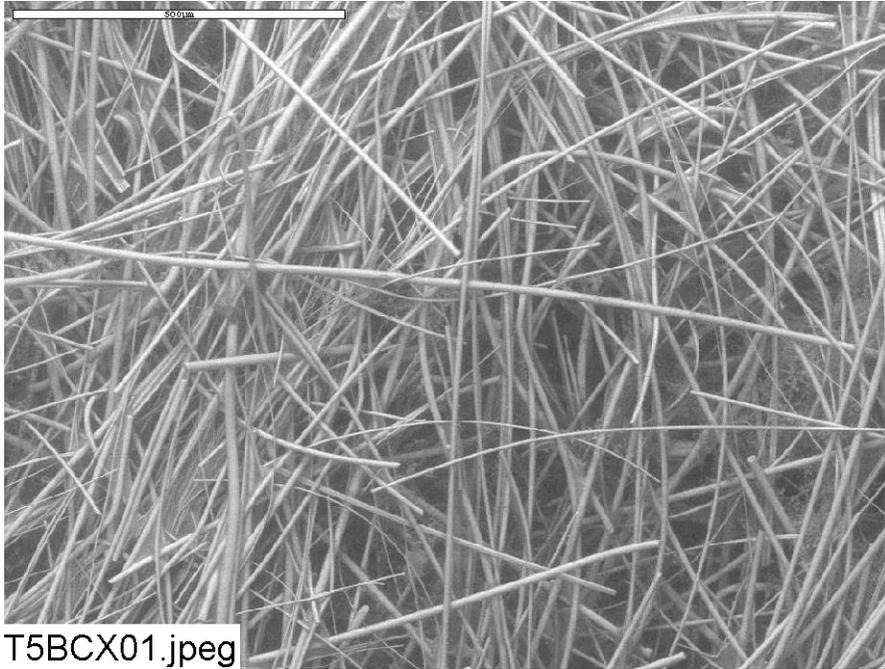
Figure C7-1. ESEM image magnified 100 times for a Test #5, Day-30 exterior fiberglass sample within the birdcage. (T5BCX01.jpeg)

Image:	T5BCX01	100 ×	ESEM image	Figure C7-1
	t5bcx02	100 ×	ESEM image	Figure C7-2
	t5bcx03	500 ×	ESEM image higher magnification	Figure C7-3
EDS:	t5bcx04		EDS on particles on t5bcx03	Figure C7-4
Image:	t5bcx05	500 ×	ESEM image	Figure C7-5

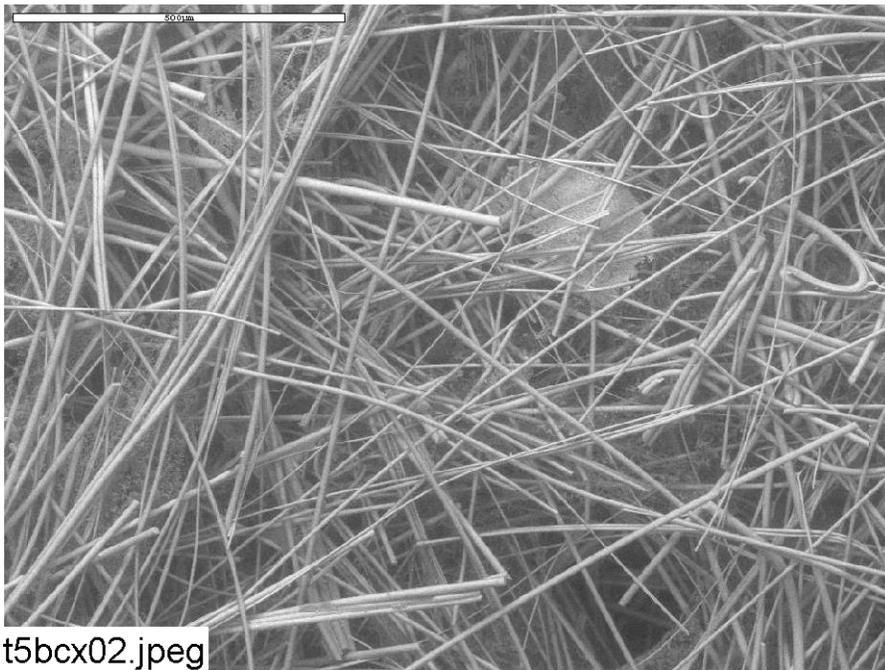
Figure C7-2. ESEM image magnified 100 times for a Test #5, Day-30 exterior fiberglass sample within the birdcage. (t5bcx02.jpeg)

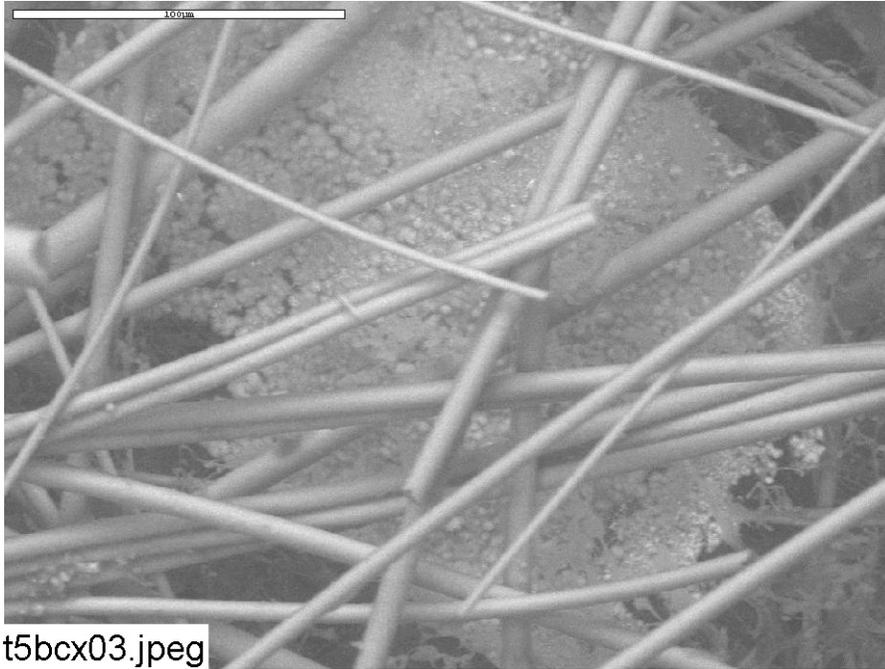
Figure C7-3. ESEM image magnified 500 times for a Test #5, Day-30 exterior fiberglass sample within the birdcage. (t5bcx03.jpeg)

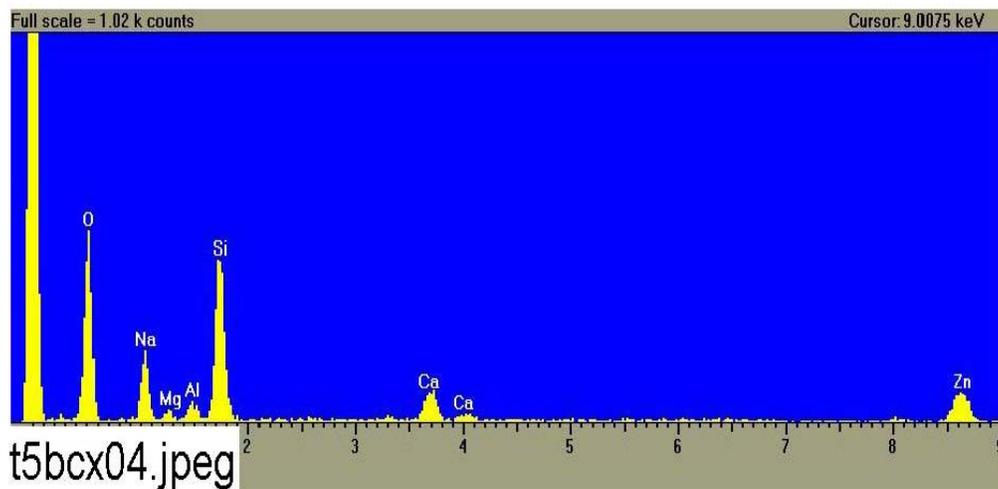
Figure C7-4. EDS counting spectrum for the deposits between fibers shown in Figure C7-3. (t5bcx04.jpeg)

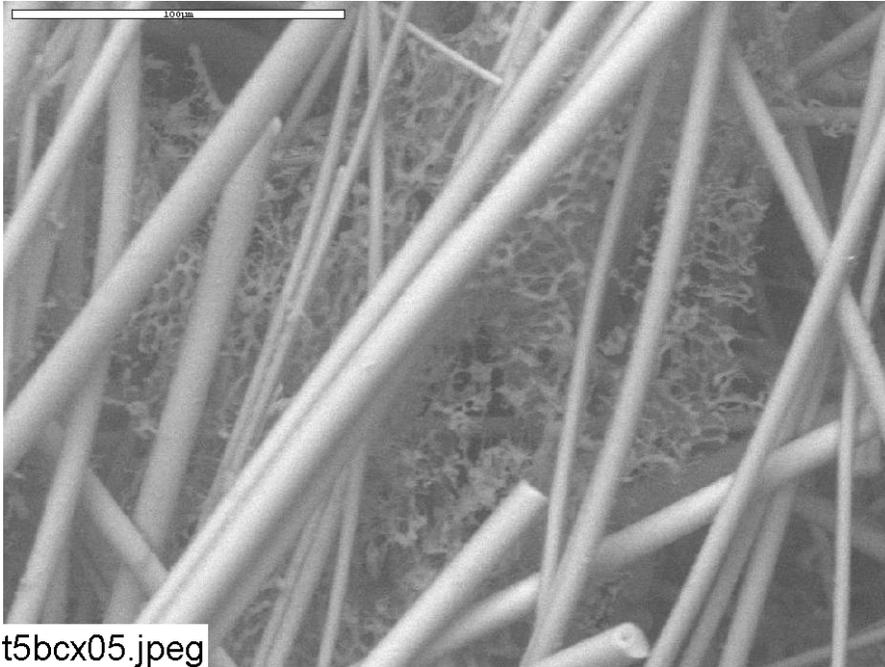
t5bcx05.jpeg

Figure C7-5. ESEM image magnified 500 times for a Test #5, Day-30 exterior fiberglass sample within the birdcage. (t5bcx05.jpeg)

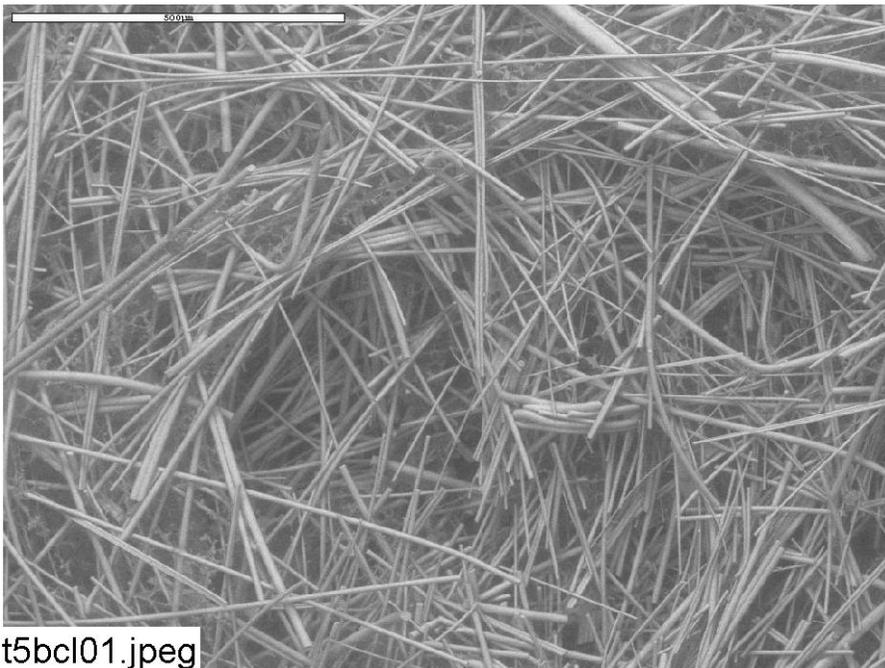
t5bcl01.jpeg

Figure C7-6. ESEM image magnified 100 times for a Test #5, Day-30 interior fiberglass sample within the birdcage. (t5bcl01.jpeg)

Image: t5bcI01	100 ×	ESEM image of fiberglass	Figure C7-6
t5bcI03	100 ×	ESEM image	Figure C7-7
t5bcI02	500 ×	ESEM image higher magnification	Figure C7-8

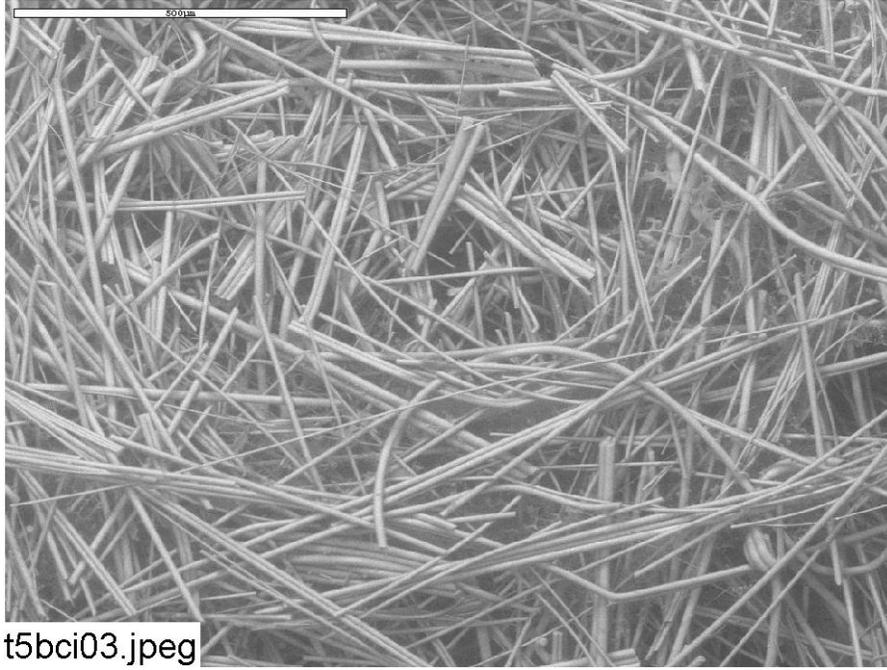
t5bci03.jpeg

**Figure C7-7.** ESEM image magnified 100 times for a Test #5, Day-30 interior fiberglass sample within the birdcage. (t5bci03.jpeg)

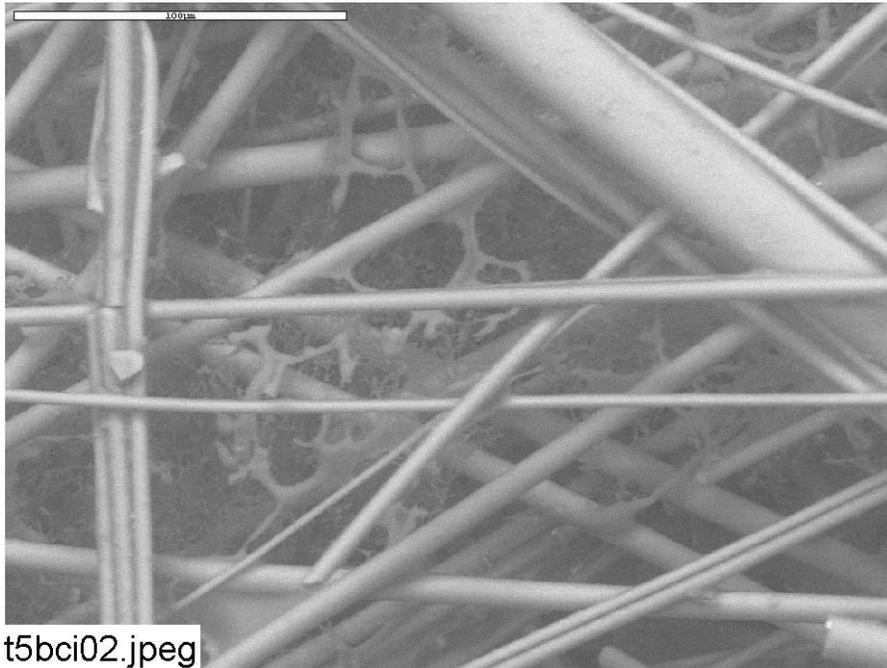
t5bci02.jpeg

**Figure C7-8.** ESEM image magnified 500 times for a Test #5, Day-30 interior fiberglass sample within the birdcage. (t5bci02.jpeg)

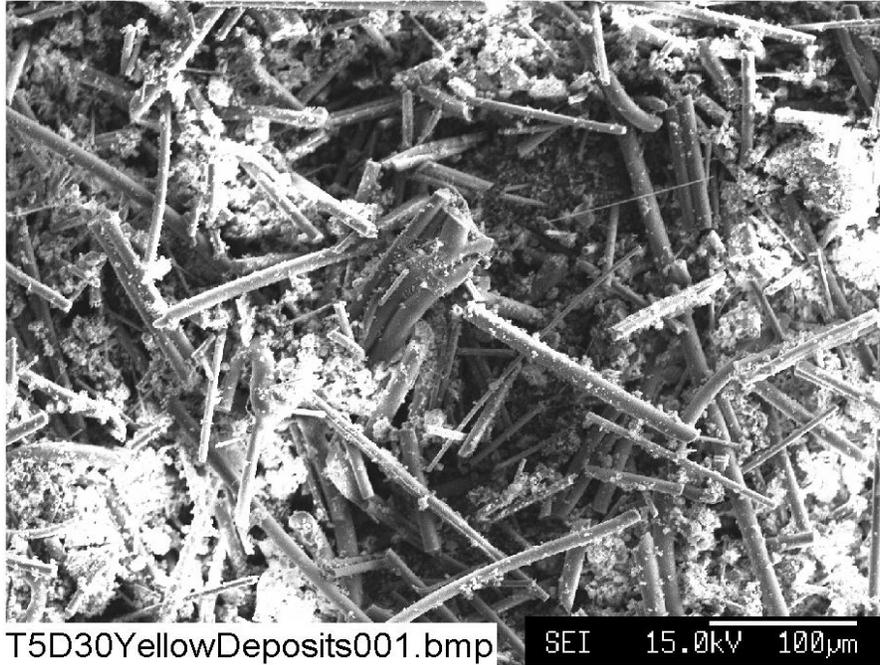
Figure D-1. SEM image magnified 100 times for the Test #5, Day-30 fine yellow powder on the submerged rack. (T5D30YellowDeposits001.bmp)

Deposition products were collected on the date Test #5 was shut down (August 25, 2005). The products examined were fine yellow powders that had deposited on a horizontal piece of the submerged CPVC rack.

Image:	T5D30YellowDeposits001	100 ×	SEM image	Figure D-1
	T5D30YellowDeposits002	500 ×	SEM image	Figure D-2
	T5D30YellowDeposits003	1000 ×	Annotated SEM image	Figure D-3
EDS:	T5D30yllw~partcl02		EDS on particulate deposits	Figure D-4

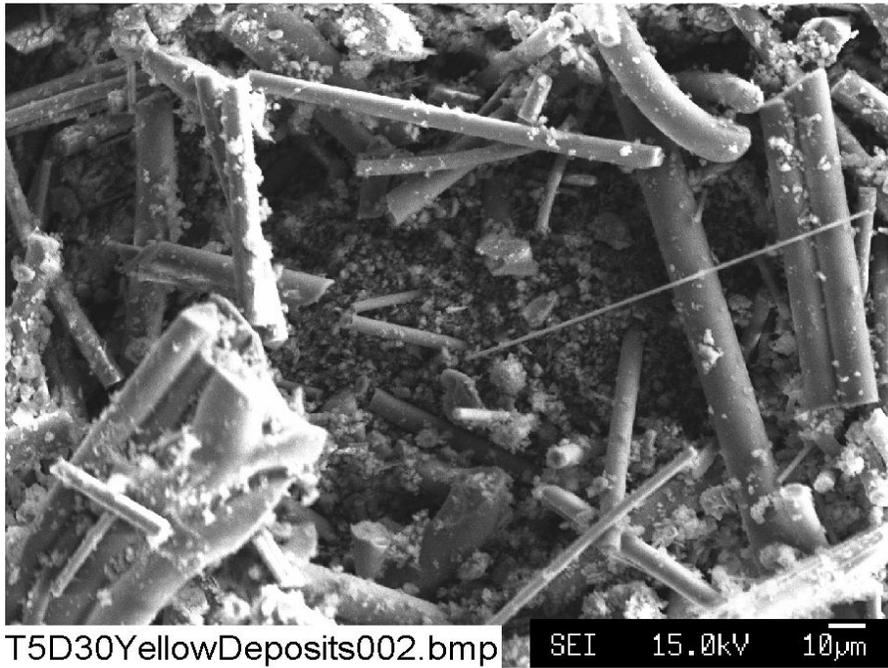
Figure D-2. SEM image magnified 200 times for the Test #5, Day-30 fine yellow powder on the submerged rack. (T5D30YellowDeposits002.bmp)

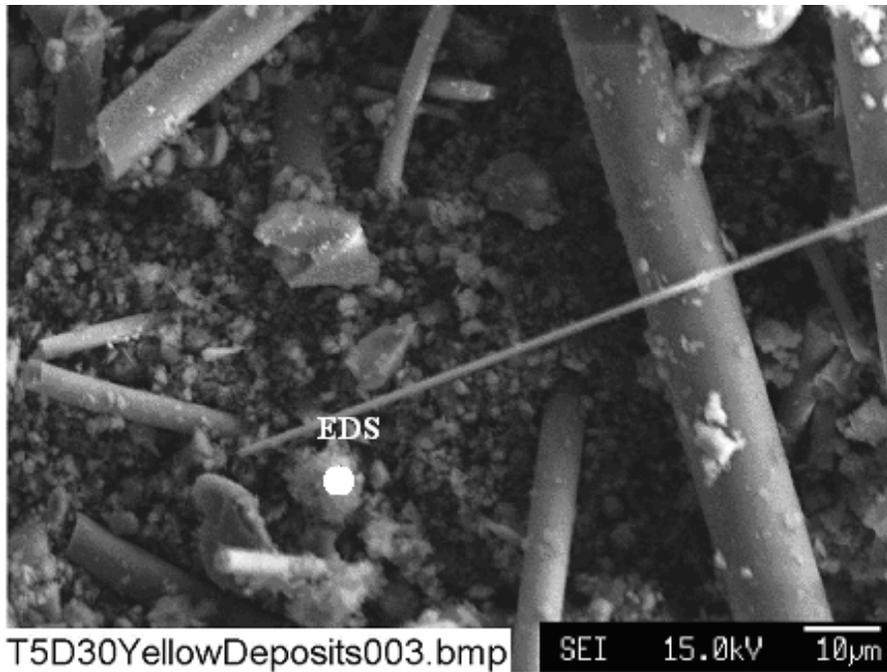
Figure D-3. Annotated SEM image magnified 1000 times for the Test #5, Day-30 fine yellow powder on the submerged rack. (T5D30YellowDeposits003.bmp)

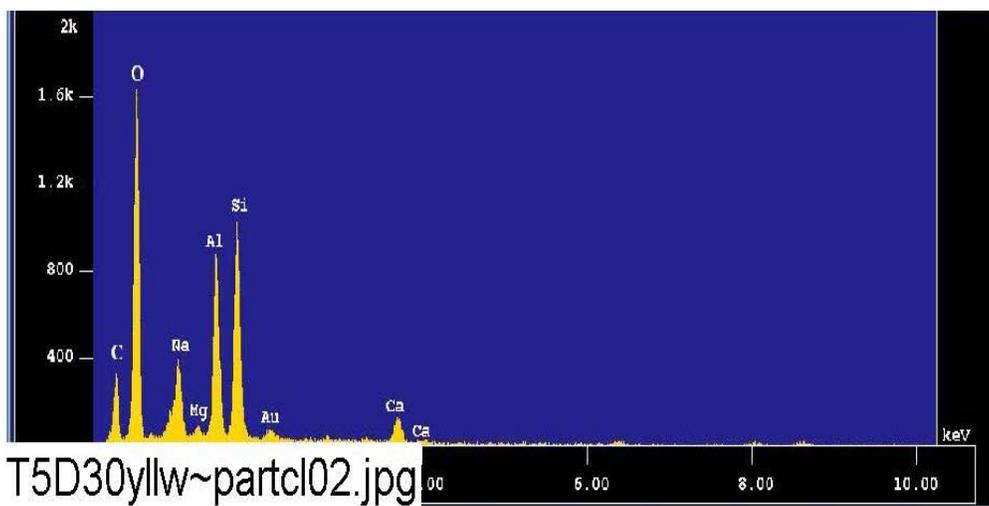
Figure D-4. EDS counting spectrum for the particulate deposit shown in Figure D-3. (T5D30yllw~partcl02.jpg)

The results from the chemical composition analysis for T5D30yllw~partcl02.jpg are given in Table D-1.

Group      : NRC
Sample     : T5D30 ID# : 30
Comment    : Yellow deposits on submerged rack
Condition  : Full Scale : 20KeV(10eV/ch,2Kch)
             Live Time  : 76.130 sec   Aperture #   : 5
             Acc. Volt  : 15.0 KV      Probe Current : 1.996E-08 A
             Stage Point: X=45.414 Y=58.152 Z=11.027
             Acq. Date  : Tue Sep 6 10:38:29 2005
